Contract #: 04-0120F4Cty: SF/ALA Rte: 80 PM: 13.2/13.9File #: 1.28**WELDING INSPECTION REPORT****Resident Engineer:**Pursell, Gary**Address:** 333 Burma Road**City:** Oakland, CA 94607**Report No:** WIR-016336**Date Inspected:** 19-Aug-2010**Project Name:** SAS Superstructure**OSM Arrival Time:** 700**Prime Contractor:** American Bridge/Fluor Enterprises, a JV**OSM Departure Time:** 1530**Contractor:** American Bridge/Fluor Enterprises, a JV**Location:** Jobsite**CWI Name:** See below**CWI Present:** Yes No**Inspected CWI report:** Yes No N/A**Rod Oven in Use:** Yes No N/A**Electrode to specification:** Yes No N/A**Weld Procedures Followed:** Yes No N/A**Qualified Welders:** Yes No N/A**Verified Joint Fit-up:** Yes No N/A**Approved Drawings:** Yes No N/A**Approved WPS:** Yes No N/A**Delayed / Cancelled:** Yes No N/A**Bridge No:** 34-0006**Component:** SAS OBG**Summary of Items Observed:**

WELDING INSPECTION REPORT

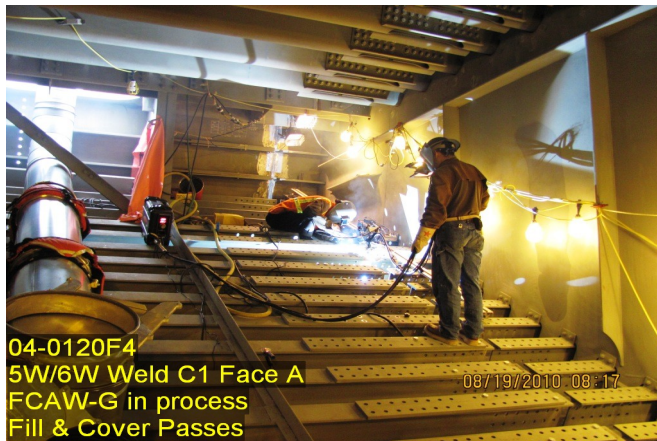
4). OBG Field Splice 5W/6W Weld ID: C1, Face A

The QAI periodically observed AB/F approved welder Song Tao Huang (ID 3794) performing welding per the Flux Cored Arc Welding (FCAW-G) process in the 3G (vertical) position of fill and cover passes on weld ID: C1. See photo below. The QAI observed QC Inspector Tony Sherwood was present to monitor the progress and verify that the welding parameters were within the limits established by the approved welding Procedure Specification (WPS) identified as ABF-WPS-D1.5-3042B-1. The QAI observed the QC Inspector monitoring and recording the welding parameters and observed the following: 24.2 welding volts, 250 welding amps and travel speed of 280mm/min. The QAI observed that the work at this location appeared to be in general compliance with contract documents.
